Bridging the Technical-to-Layperson Gap for Environmental Matters at the US Postal Service

Federal Environmental Symposium 2019
Best Environmental Practices Section
Natcher Conference Center, National Institute of Health, Bethesda, MD
October 31, 2019 9-9:30am

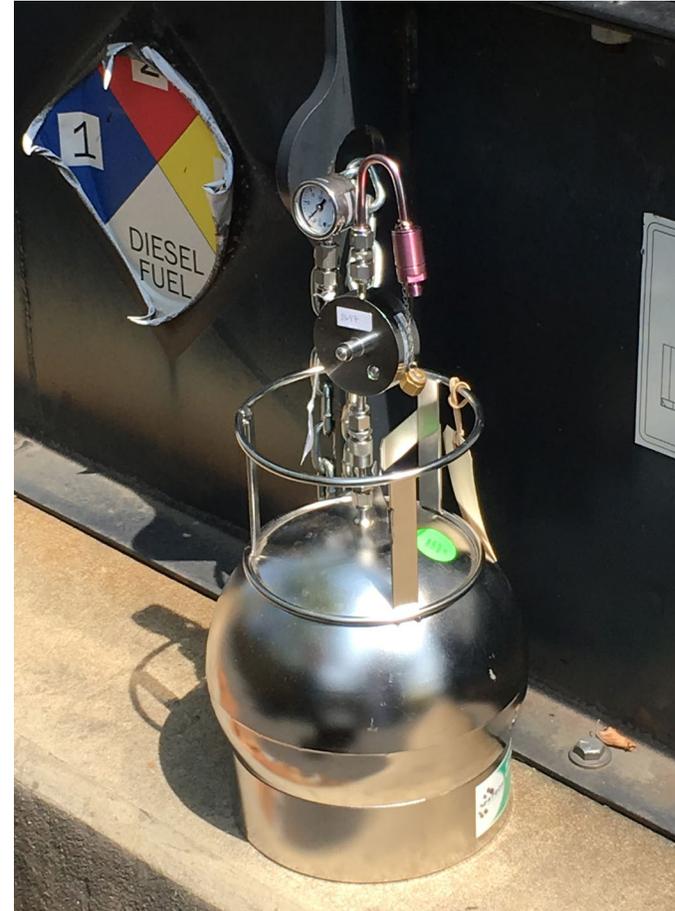
Summa Canister – Newark NJ MPO

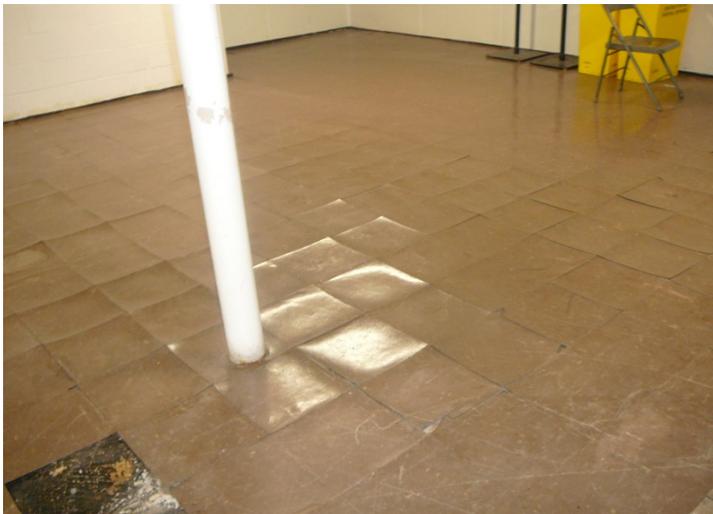
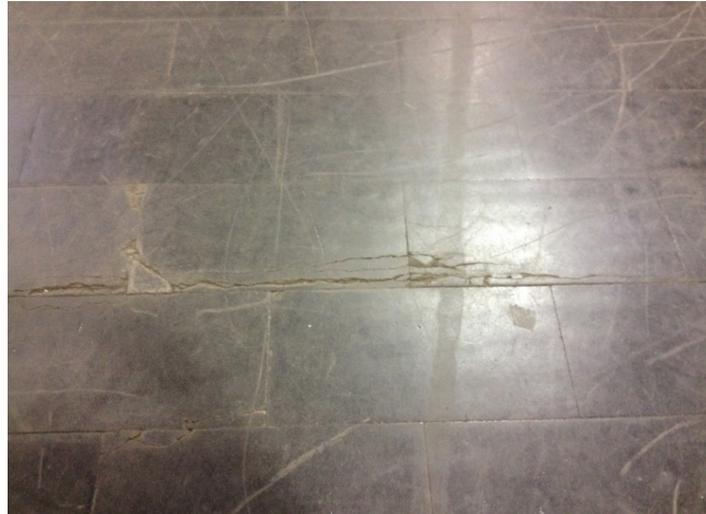
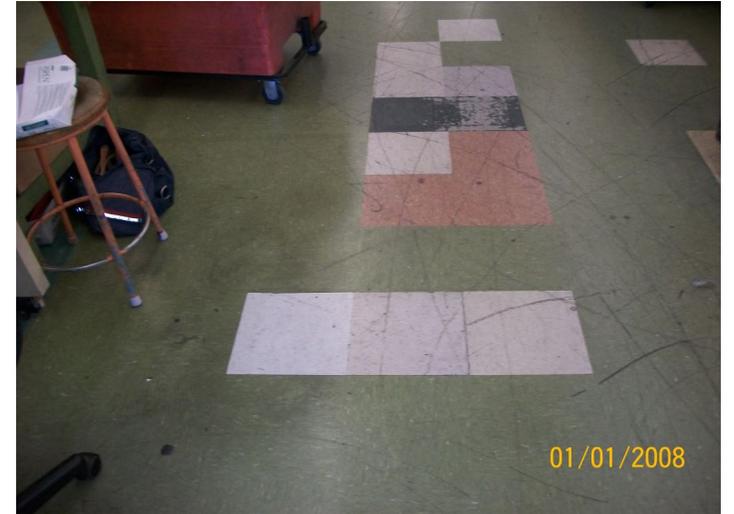
Asbestos flooring is USPS's most frequent asbestos concern:

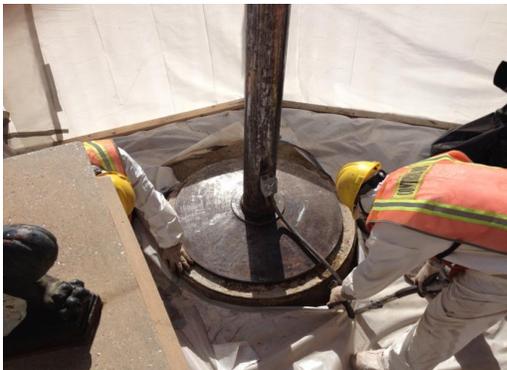
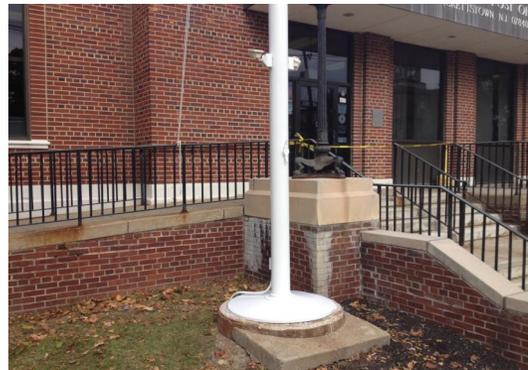
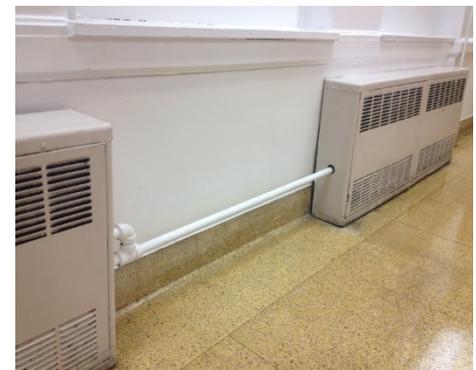
- USPS lead paint policy is not the same as asbestos as far as requiring IH oversight, but it often does as OSHA requires us to prove NO excessive lead exposure
- Understanding the basics of work practices, oversight and **the power of wipe samples** goes a long way.. (from a 2019 NJ IH oversight report)...

‘Lead-dust wipe clearance samples were collected and **compared to the results of the background wipe samples** collected prior to the LBP disturbing activities to verify the effectiveness of the cleaning. The results of all post-stabilization clearance wipe samples collected from surfaces in and around the work area(s) were below the analytical methods limit of detection (<10 micrograms of lead dust per square foot of surface sampled ($\mu\text{g}/\text{ft}^2$)), which were significantly below the background/pre-stabilization wipe sample results for each corresponding area and below recognized HUD clearance levels for floors ($10 \mu\text{g}/\text{ft}^2$) and window sills / troughs ($100 \mu\text{g}/\text{ft}^2$) (also applied to sills, ledges, and walls). **All final lead-dust wipe sample results indicated that the stabilization and cleanup activities were effective...**’

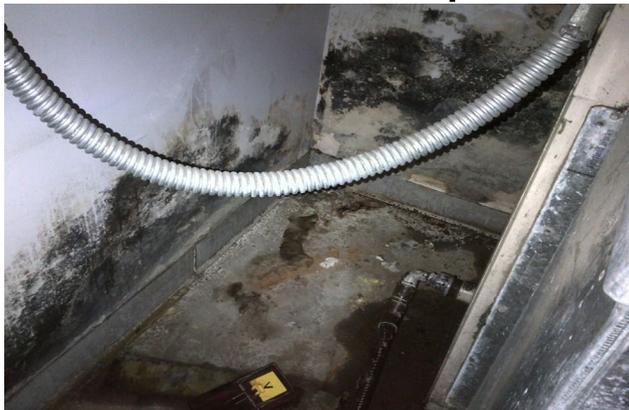
Budd Lake NJ MPO

Pictures for suspect mold issues are powerful (efflorescence; dirt; water) as is the role of repair and alterations AND Safety/Medical staff

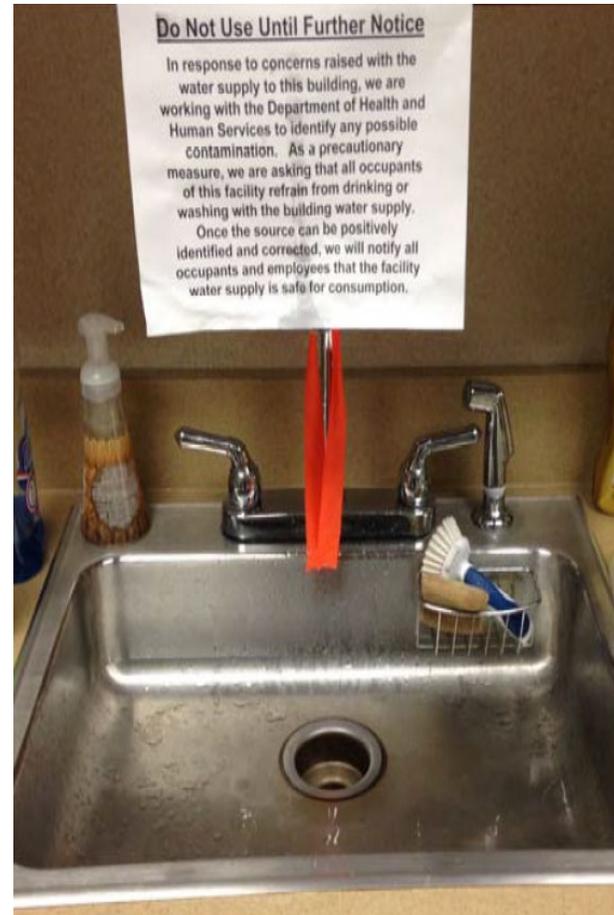
**LEAD IN DRINKING WATER
ADVISORY**

IT HAS BEEN DETERMINED THAT THIS
WATER OUTLET NEEDS TO BE
FLUSHED DAILY (e.g. early in the
morning) PRIOR TO BEING USED AS A
DRINKING WATER SOURCE

**RUN THE TAP FOR ONE MINUTE
PRIOR TO CONSUMPTION**
(e.g., coffee, soup, or drinking)

Water quality warnings

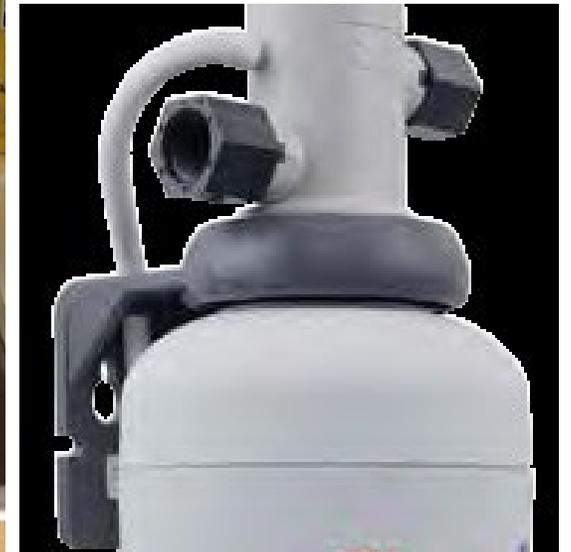
Lead filter device

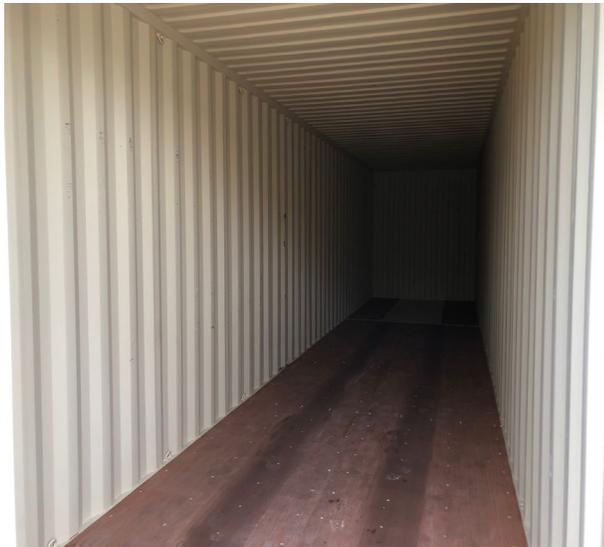
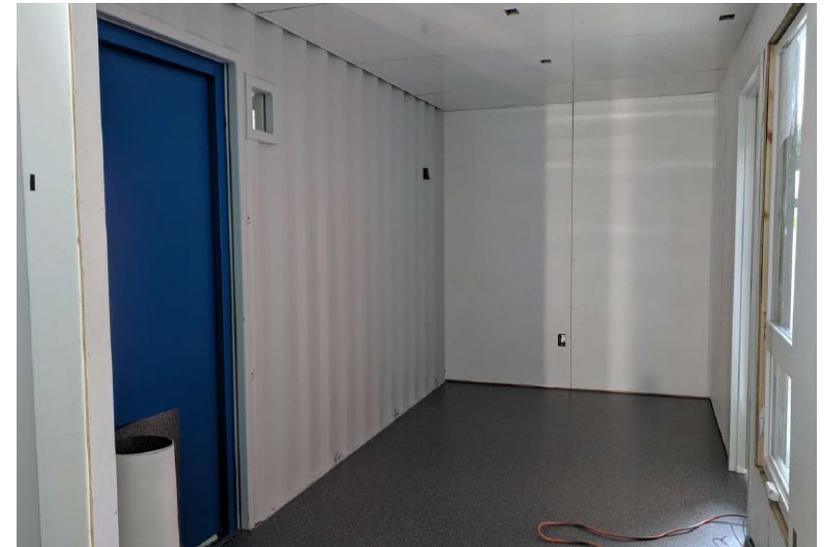
Contaminated Property – Shipping Container Pilot Program

- In addition to site selection, sometimes the *structure* needs study
- Example of how the occupant's perception is just as important as any actual facts they present

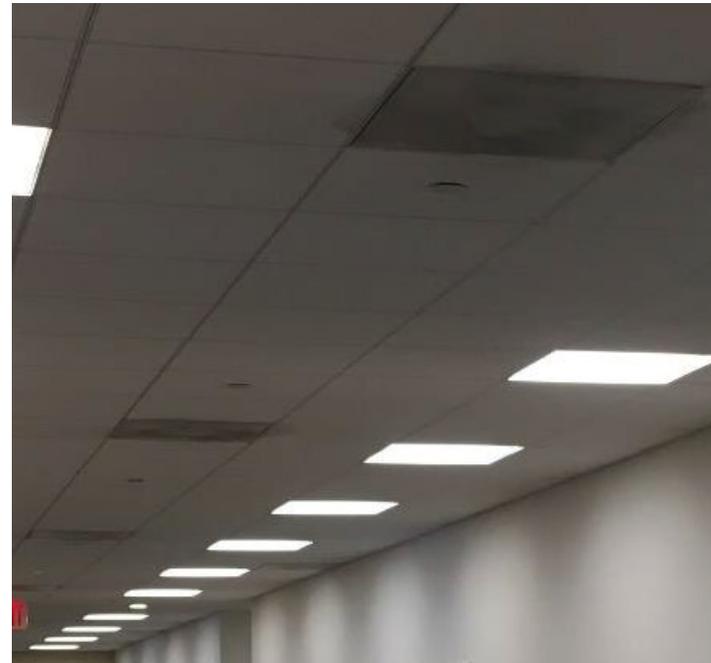
- 2019 Indoor Air Study at 90 Church St. Station, NY, NY

Deposits of dirt and dust were observed on the ceiling tiles adjacent to the seven supply diffusers in the common areas above Cubicles 1, 2, and 3. These deposits usually originate from one of two sources: the primary supply airstream being unfiltered or picking up dirt and dust from the HVAC system ducts, or turbulence around the diffusers picking up particulates generated from activities in the conditioned and/or occupied space.

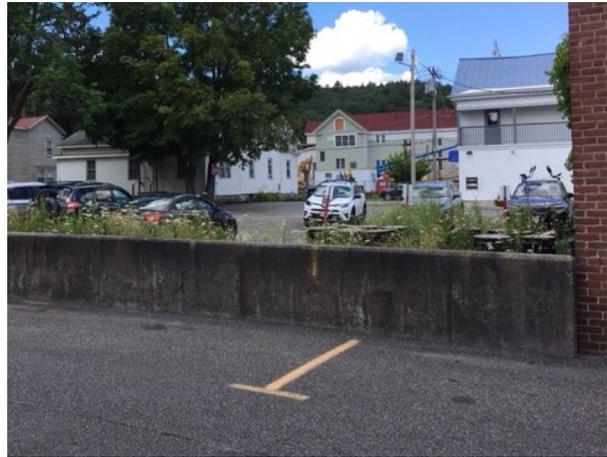
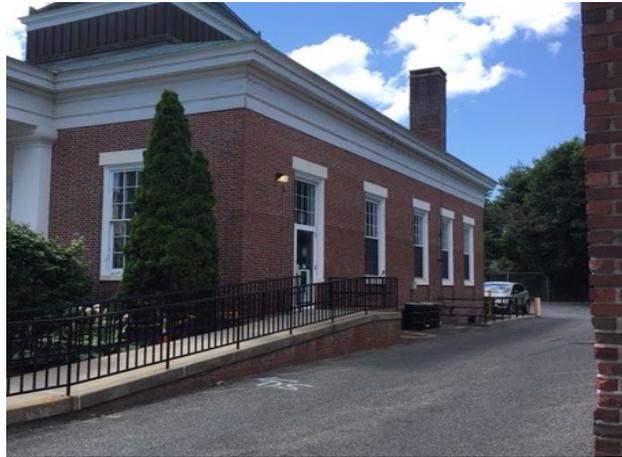
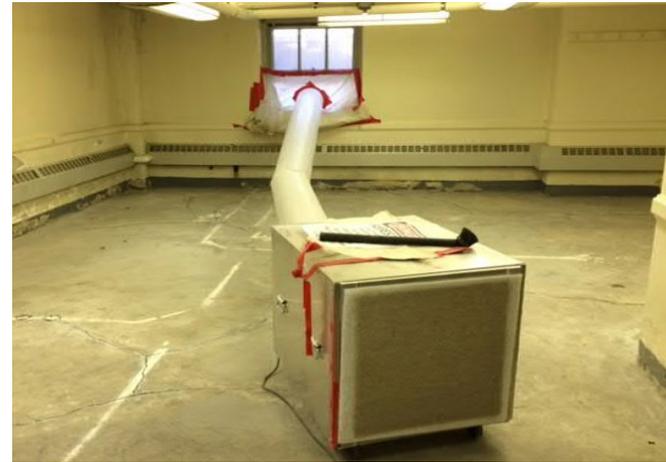
Great Barrington
MA MPO

- USPS has circa 2009 vapor intrusion guidance based on mounting concerns at the time, such as states re-opening closed contamination cases based on lowering vapor-related exposure thresholds, or newly establishing them

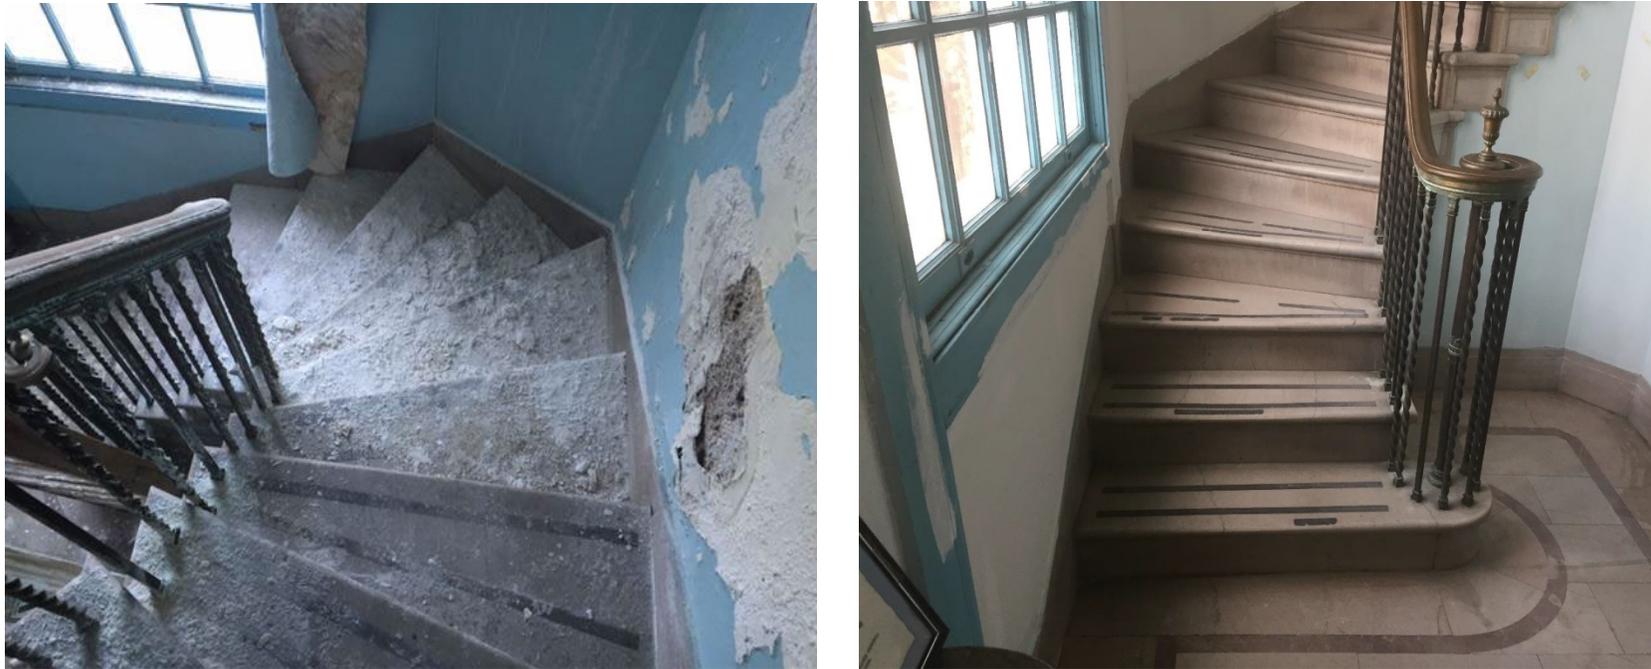
Before and after at Morrisville NJ MPO
